* Natural Disaster and Accidents

In Thailand Railway System

(Case Studies)"

Department of Rail Transport

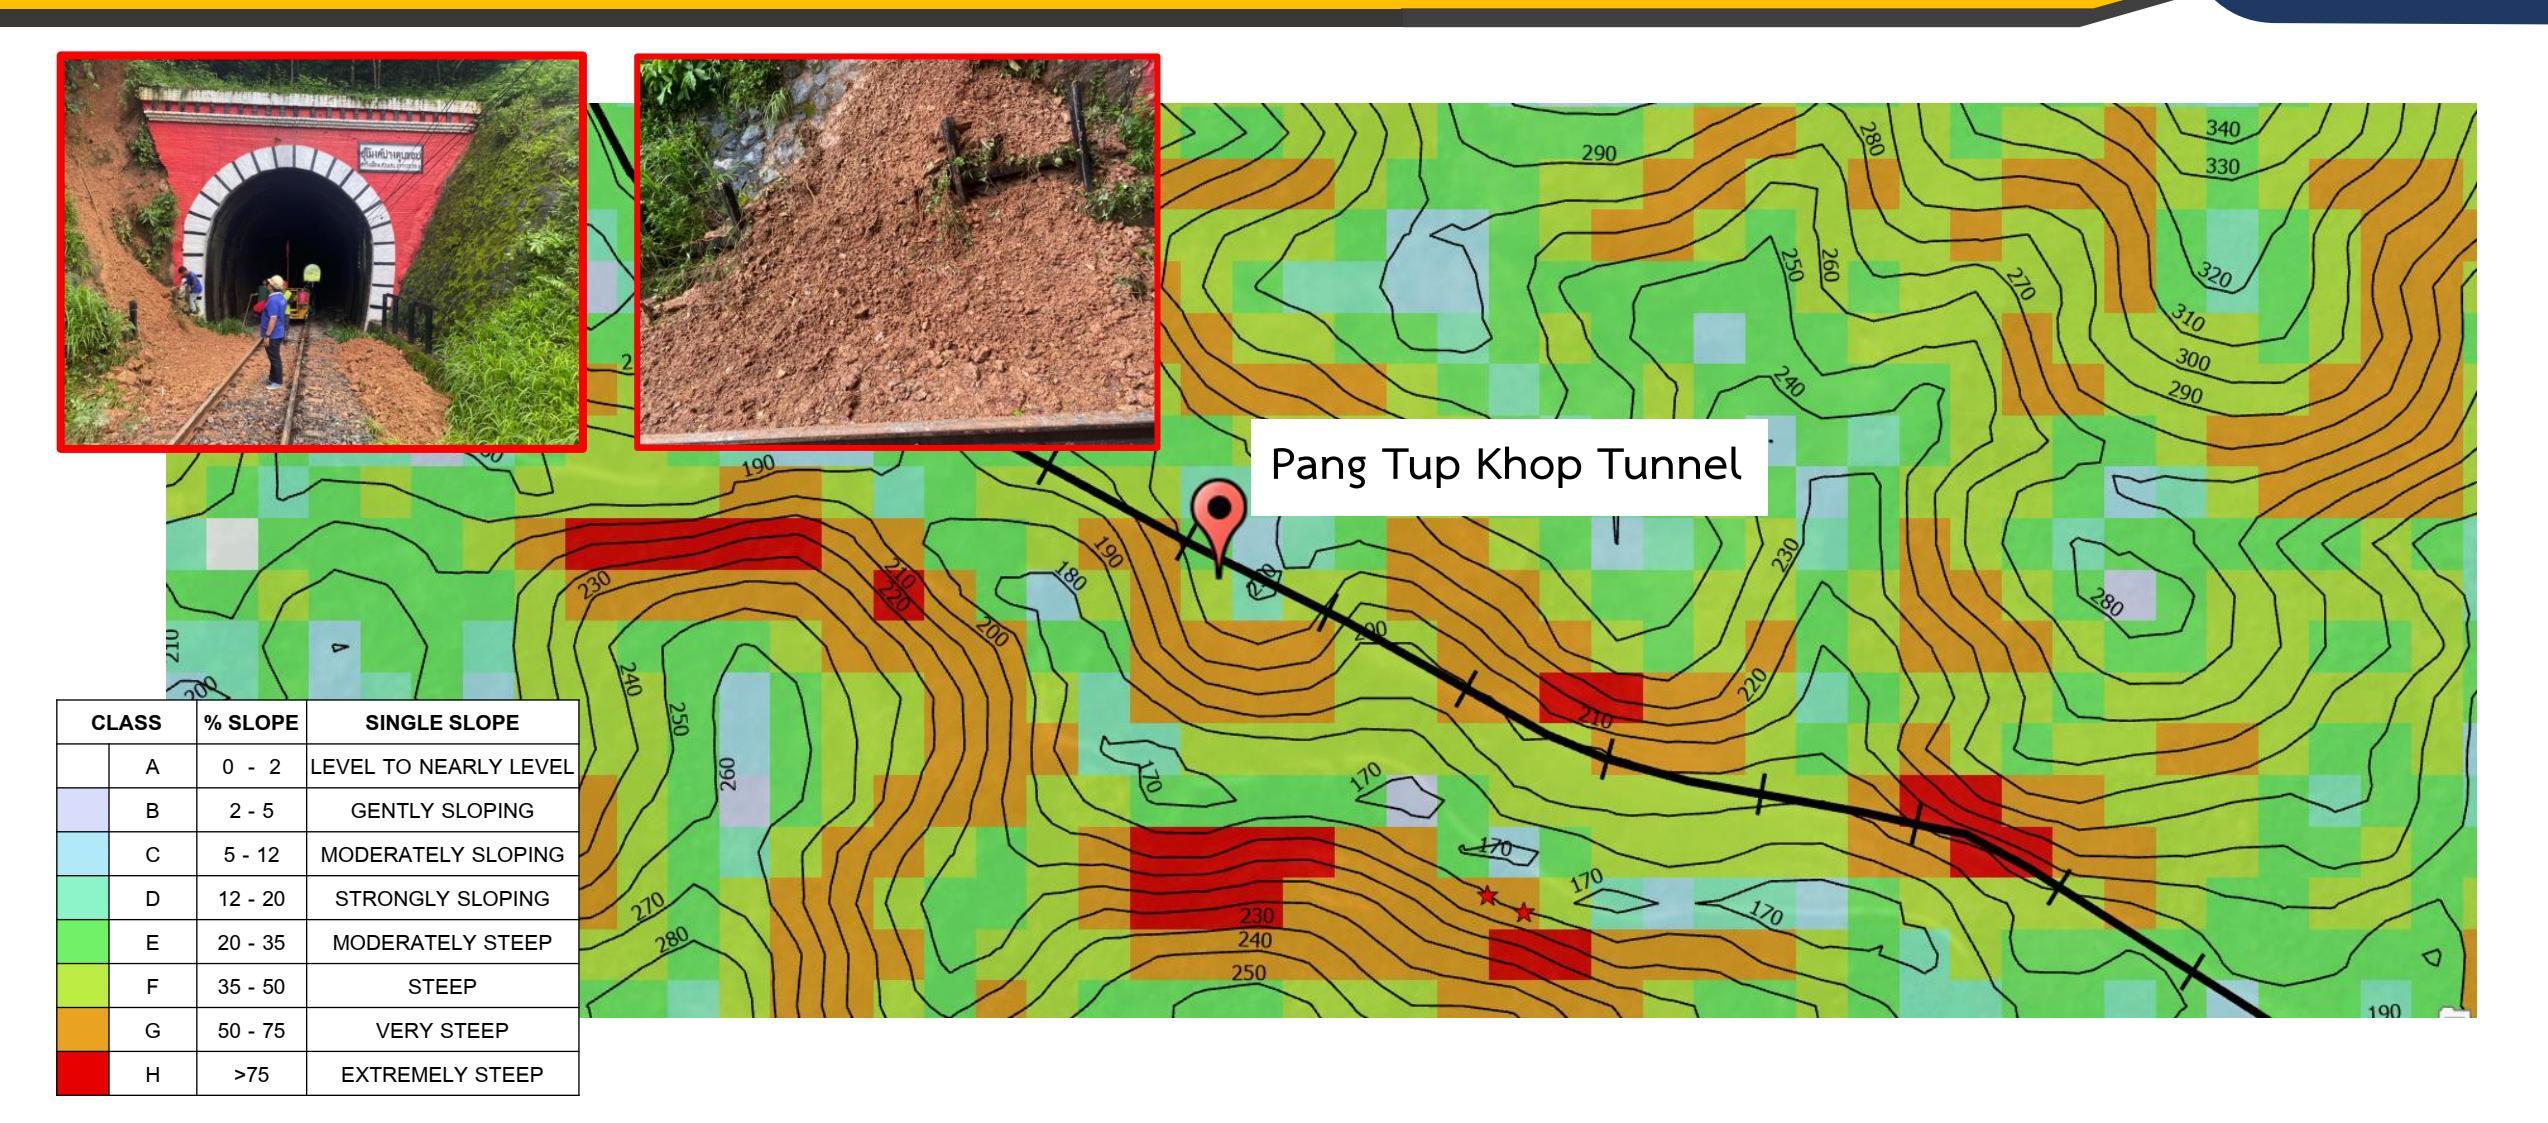
Case Study 2 : Landslide (Pang Ton Phung – Huai Rai, Phrae province)

Landslide occurred from the side of the tunnel entrance, and water flowed from above the tunnel down along the slope, causing flooding on the tracks and water to flow into the tunnel. **Shotcrete and Surface Drainage System** at the portal tunnel provides a comprehensive solution, including soil reinforcement and water management, to prevent landslides and erosion around the tunnel entrance. This approach ensures long-term maintainability.

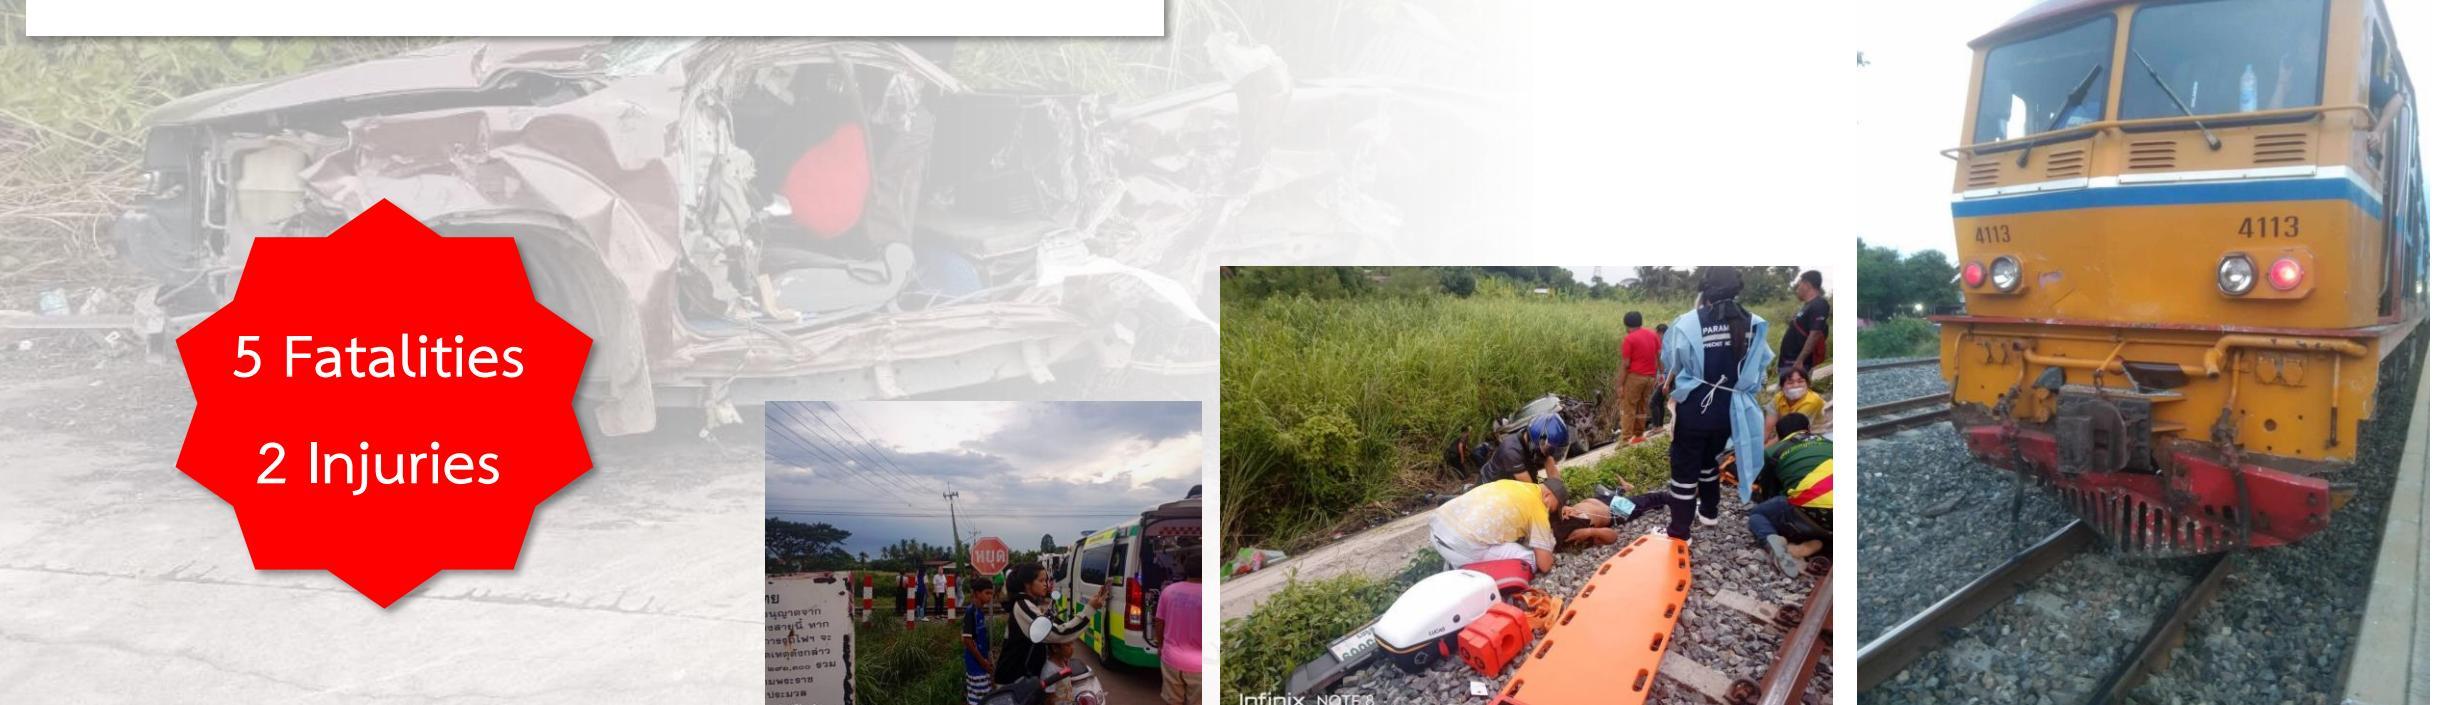
Time Line: 06:09 PM, the Train No. 201 was passing through an illegal crossing between Phichit Station and Tha Yalo Station, a pickup truck drove in front of the train at close range. As a result, the train collided with the left side of the pickup truck.

The illegal crossing equipped with speed bumps, a stop sign, and a flashing light warning sign before the crossing. The crossing was also fitted with high-strength pre-stressed concrete slabs, and the area was a straight path for both the railway and the road. The lighting was adequate, and there was no rain at the time.

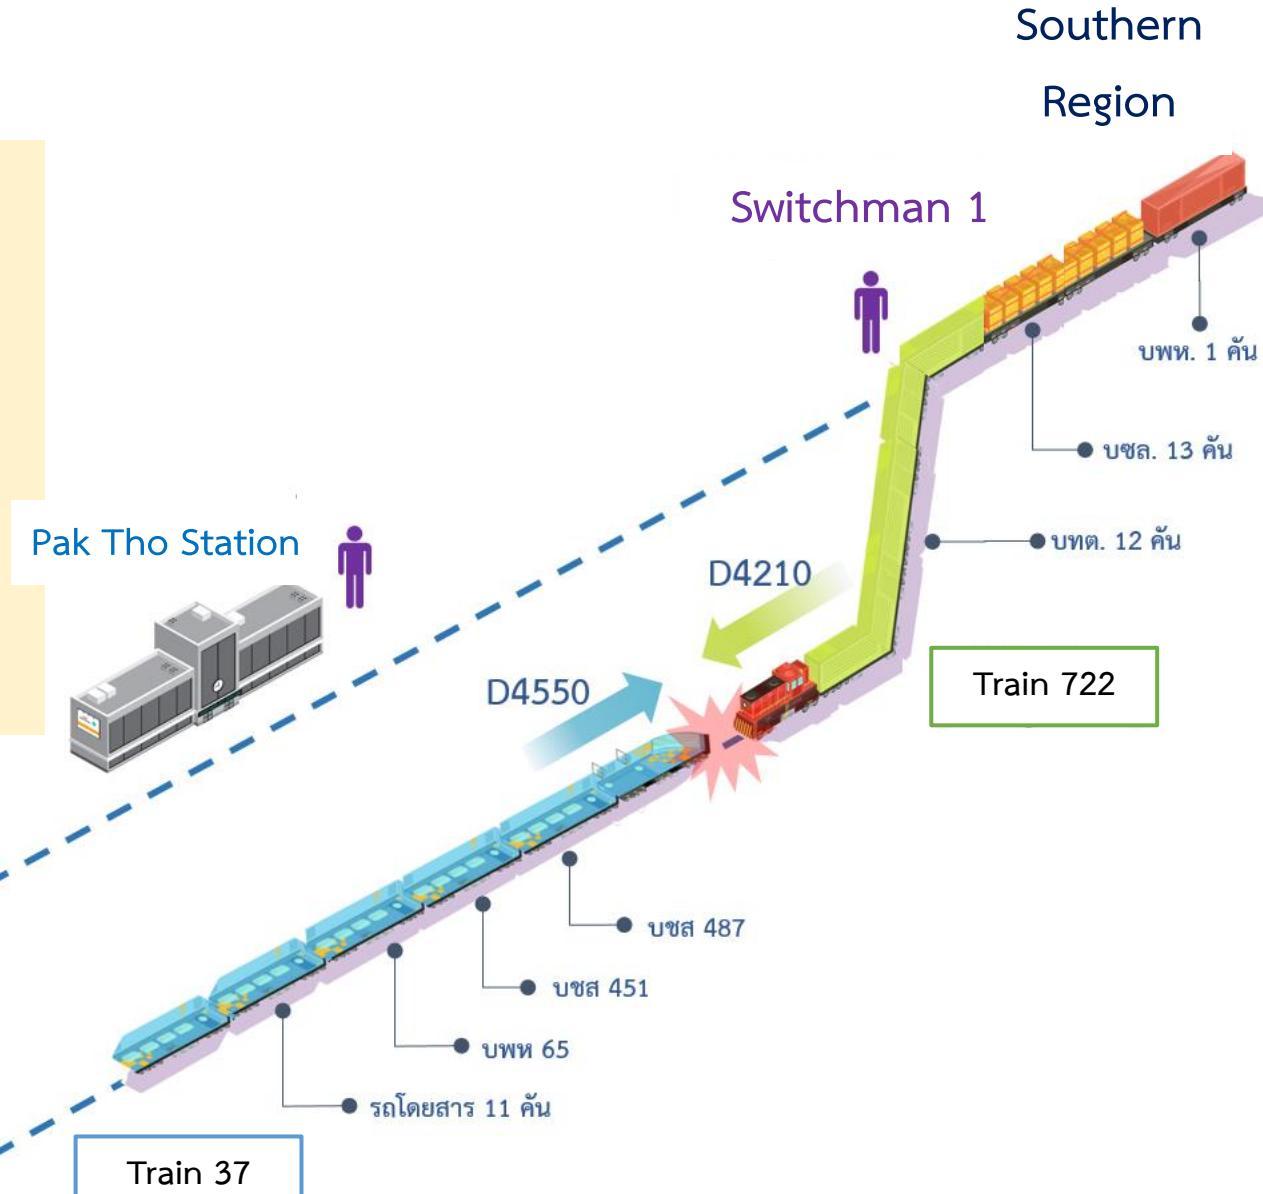
Case Study 4 : Train-Train Collision

The incident occurred at the side-track in the vicinity of the Pak Tho Railway Station, Ratchaburi Province.

- The area is undergoing a double track railway construction project, which temporarily suspended the signaling system.
 Instead, 2 Switchman were assigned, one to the north and one to the south.
- At the time of the incident, the south switch did not return to the main track, causing train 722 to pass through the switch and collide with train 37.
